Joint Sector Group for ERA Task Force on wagon/axle maintenance

Final report on EVIC sampling programme

ERA, Lille 13th December 2011

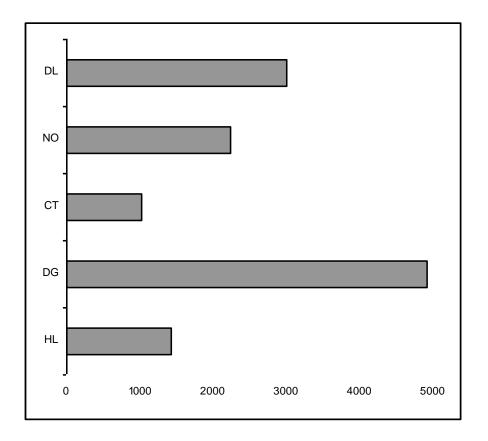
Wheelsets sampled per Risk Category, state per end of November 2011

30.11.2010:	2.930 in total
01.03.2011:	5.739 in total
30.08.2011:	10.623 in total
30.11.2011:	12.597 in total

•≈ 52% of the sampling volume has been checked up to now
