Final report on the results of the Joint Sector Group activities linked to the action plan defined under the Task Force Freight Wagon Maintenance

Joint Sector Group for ERA Task Force on wagon/axle maintenance

ANNEX 3.2.C: IMPLEMENTATION GUIDE FOR THE EUROPEAN VISUAL INSPECTION CATALOGUE (EVIC) FOR FREIGHT WAGON AXLES

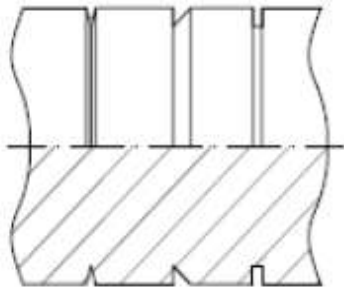
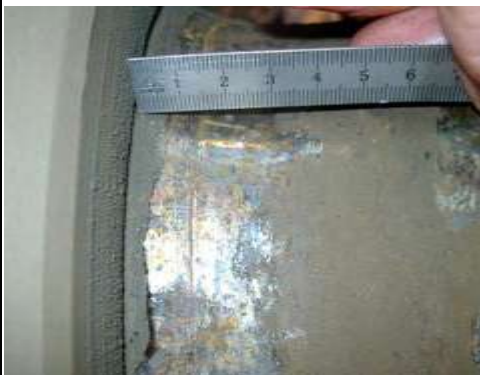
32 Mechanical damage – smooth edged circumferential grooves		Painted axles
Salient information:		
	Characterised by smooth transitions in the edges (GCU Annex 9, 1.6.1). Pitting that arises during operation (caused e.g. by brake lever connectors dragging) involves damaged anti-corrosion	
Decision:		
	Check on the wagon why this damage could have occurred and repair accordingly	
	Remove from service	Case B
	if there is damage to the base material > 1mm: (acc. GCU)	Case A
	mark 1 at “X” column in EVIC logging	X

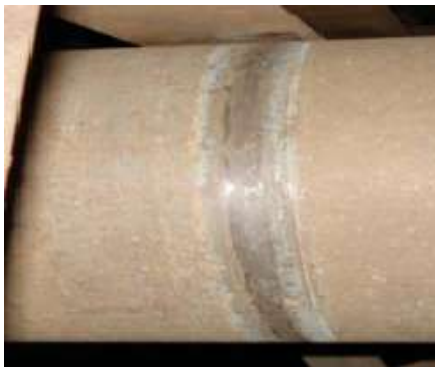
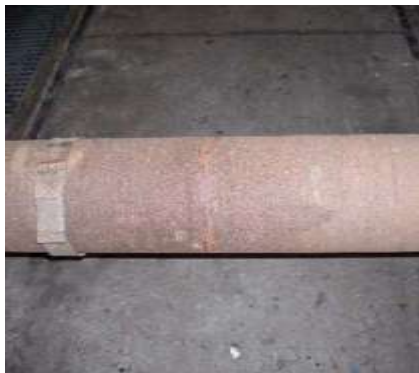
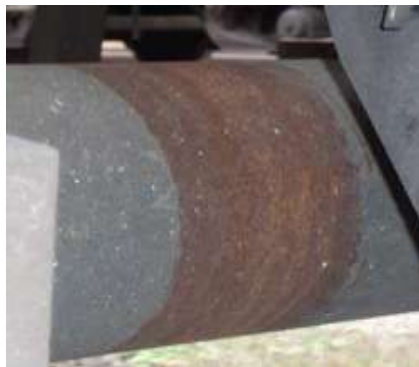
33 Mechanical damage – sharp edged notching		Painted axles
Salient information:		
	Sharp edged notches occur locally and are characterised by sharp-edged transitions.	
	Mechanical damage to the base material in the form of notching is inadmissible.	
Decision:		
	Remove from service (according to GCU criteria)	Case A
	mark 1 at “X” column in EVIC logging	X

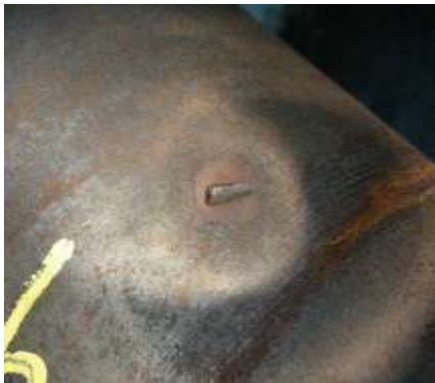
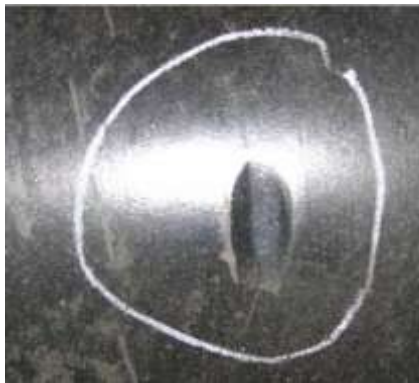
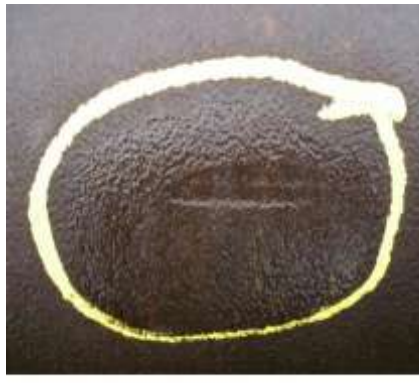
34 Mechanical damage – cracks		Painted axles
Salient information:		
	Cracks occur locally on the shaft material (not on the painting) and are characterised and visible by fine lines.	
	Mechanical damage to the base material in the form of cracks is inadmissible.	
Decision:		
	Remove from service	Case A
	mark 1 at “X” column in EVIC logging	X

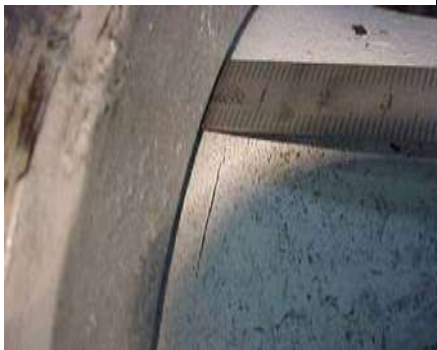
35 Surface damage – large and heavily corroded areas		Painted axles
Salient information:		
	Surface damage to base material in form of large and heavily corroded areas (old corrosion protection) is inadmissible.	
Decision:		
	Remove from service	Case B
	mark 1 at “X” column in EVIC logging	X

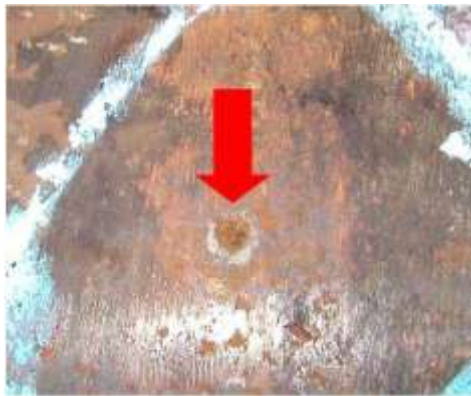
37 Coating damage – with or without corrosion		Painted axles
Salient information:		
	Minor lack of an anti-corrosion coating, whether corrosion is involved or not.	
Decision:		
	Leave in service acc. case C and/or repair the damage in situ on the wheelset	Case C
	mark 1 at “C” column in EVIC logging	C

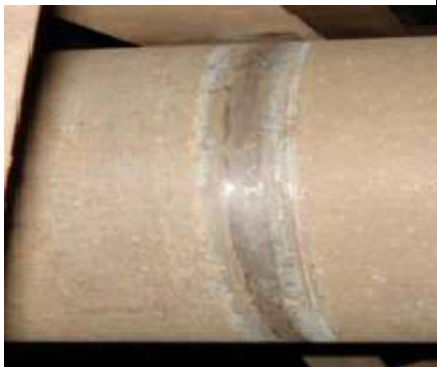
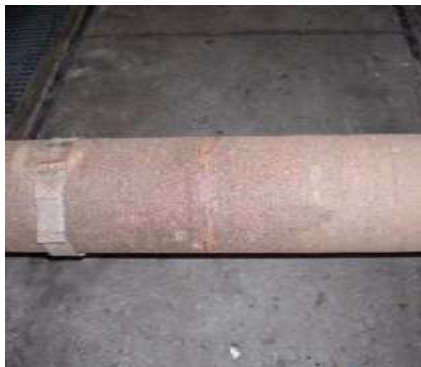
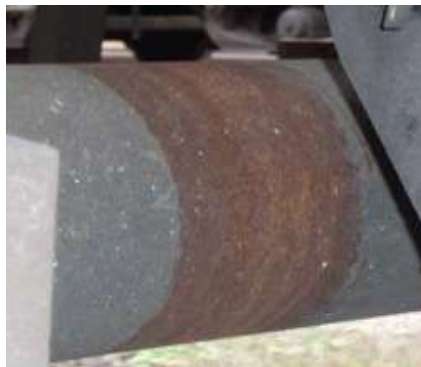
43 Mechanical damage – sharp edged notching		Unpainted axles
Salient information:		
	Sharp edged notches occur locally and are characterised by sharp-edged transitions.	
	Mechanical damage to the base material in the form of notching is inadmissible.	
Decision:		
	Remove from service (according to GCU criteria)	Case A
	mark 1 at “X” column in EVIC logging	X

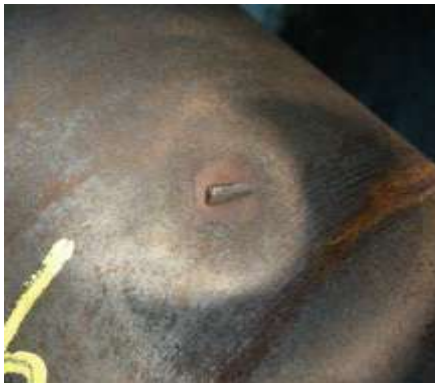
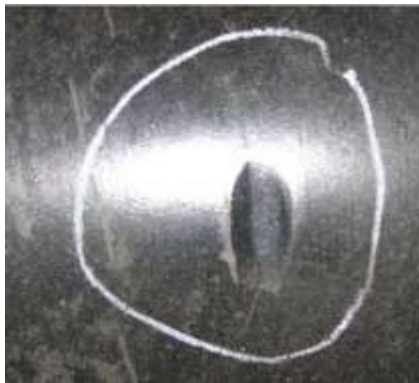
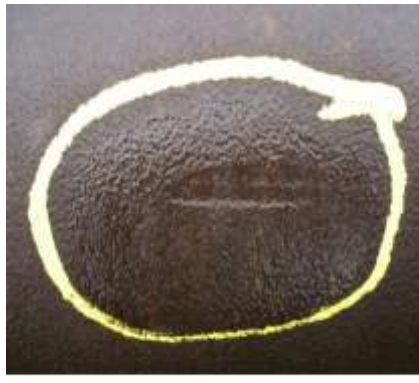
44 Mechanical damage – cracks		Unpainted axles
Salient information:		
	Cracks occur locally and are characterised and visible by fine lines.	
	Mechanical damage to the base material in the form of cracks is inadmissible.	
Decision:		
	Remove from service	Case A
	mark 1 at “X” column in EVIC logging	X

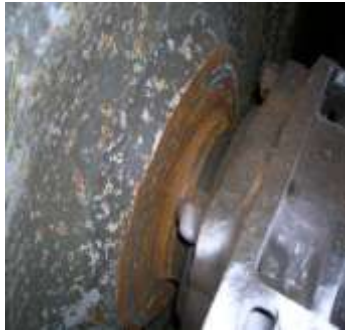
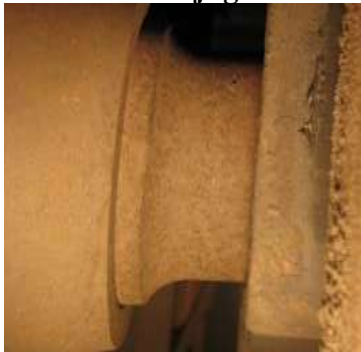
50 Abutment area		All axles
Situation:		
	Normally, the abutment area cannot be inspected sufficiently for wheelsets mounted in the wagon	
Recommendation:		
Only if there is a clear indication on mechanical or corrosion damages		
	Take wheelset out	Case A
	Mark 1 at “ X ” column in EVIC logging	X
If not judgeable		
	Leave wheelset in service	
	Mark 1 at “ OK ” column in EVIC logging	O

Pictorial representation:			
Not acceptable		Not judgeable

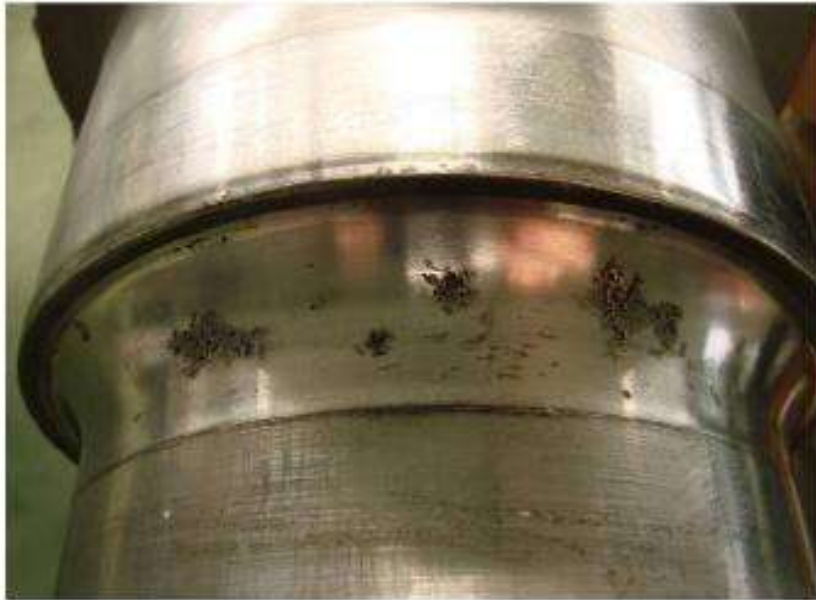
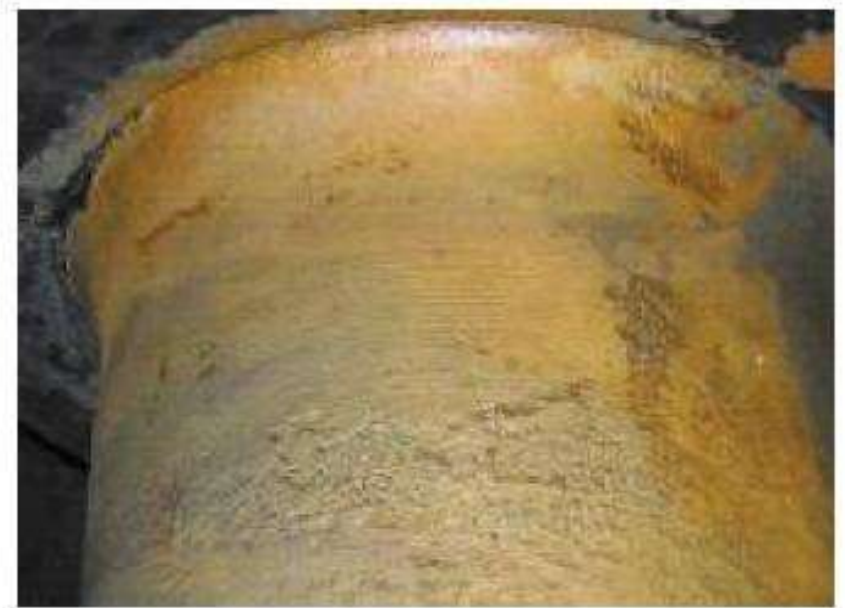
1) Local and severe defects (according UIC category 4)

Surface status to be treated in medium and heavy maintenance: references

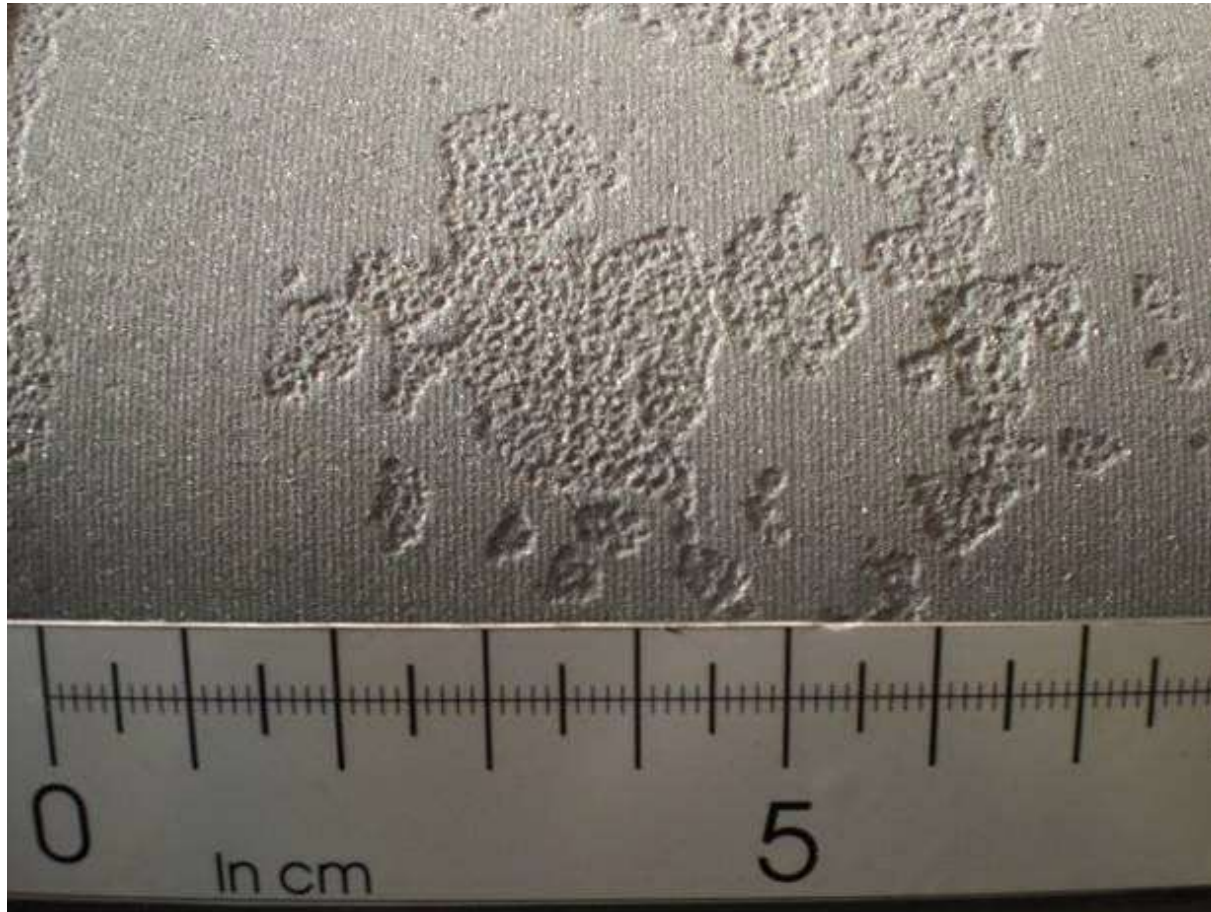
1) Local and severe defects (according UIC category 4)

Surface status to be treated in medium and heavy maintenance: references

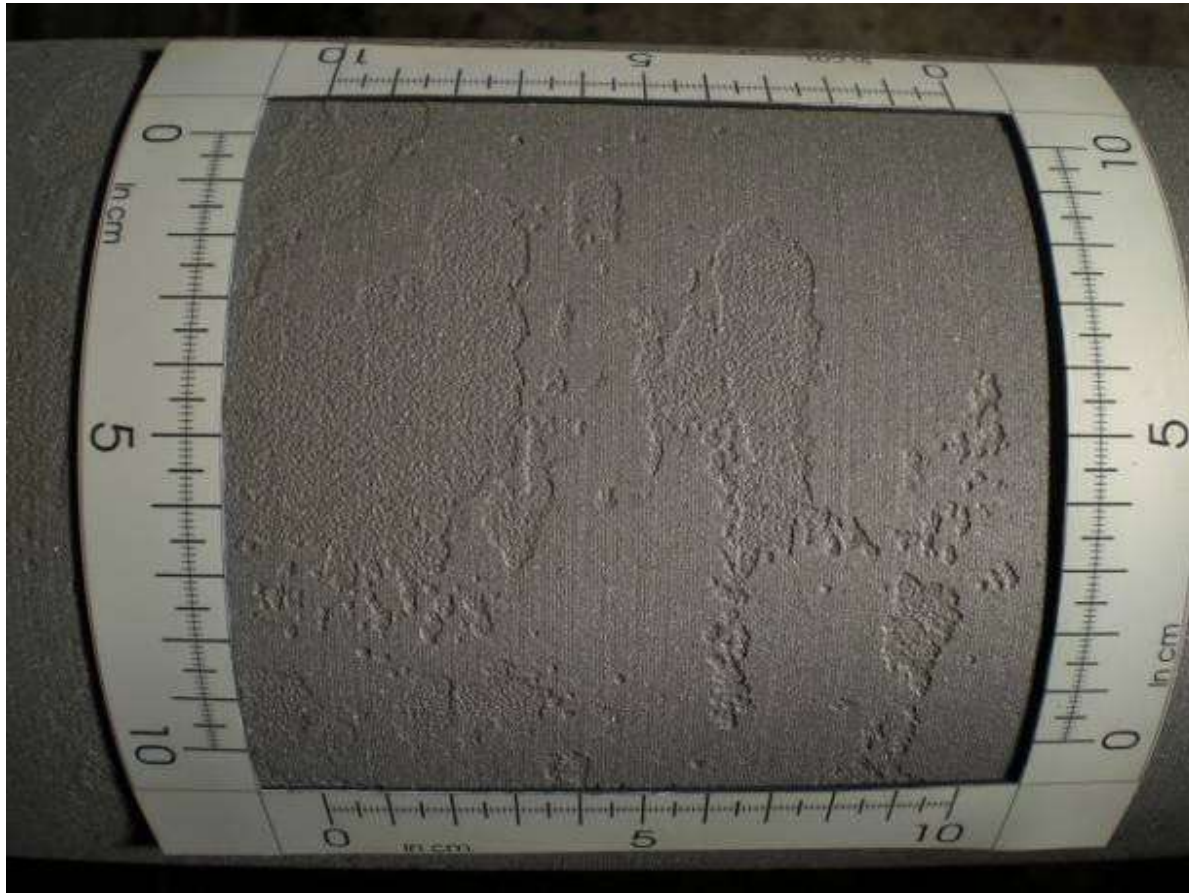
1) Local and severe defects (according UIC category 4)

Surface status to be treated in medium and heavy maintenance: references

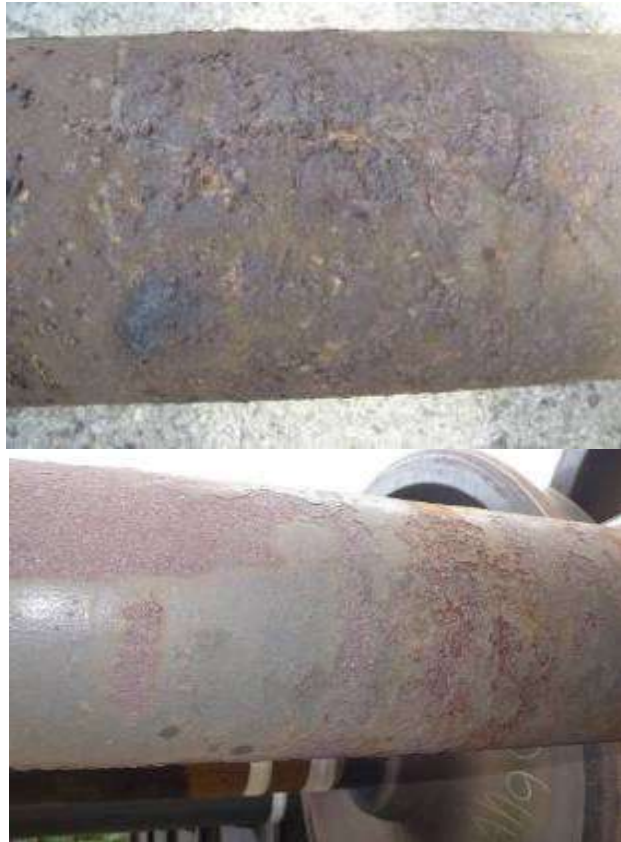
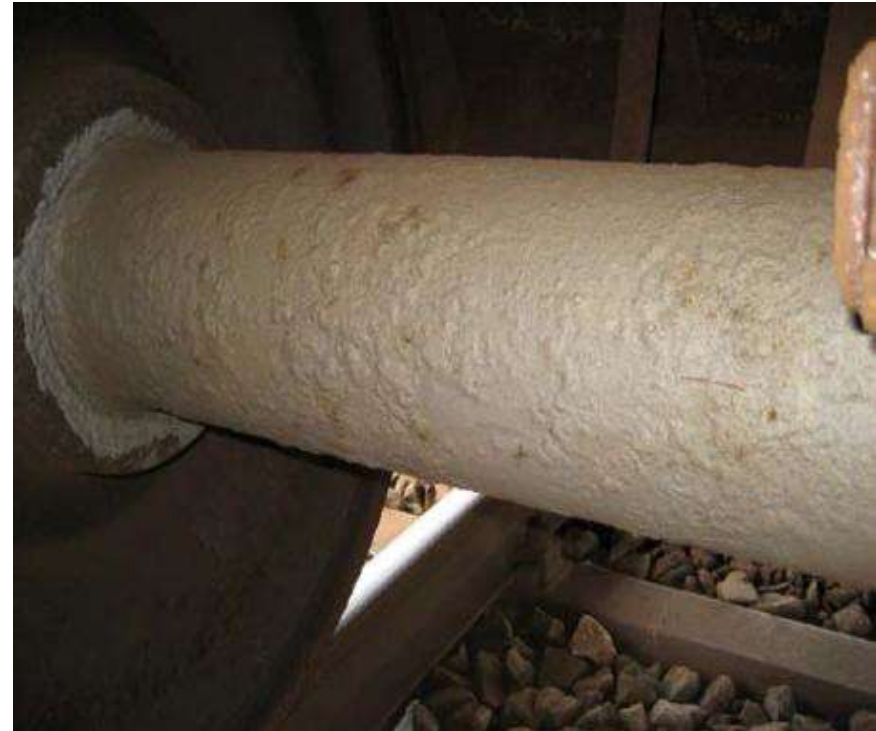
2) Large and heavily corroded areas, strongly and uniformly pitted surface

(link to prescriptions in EVIC: “to be treated in next heavy maintenance”)

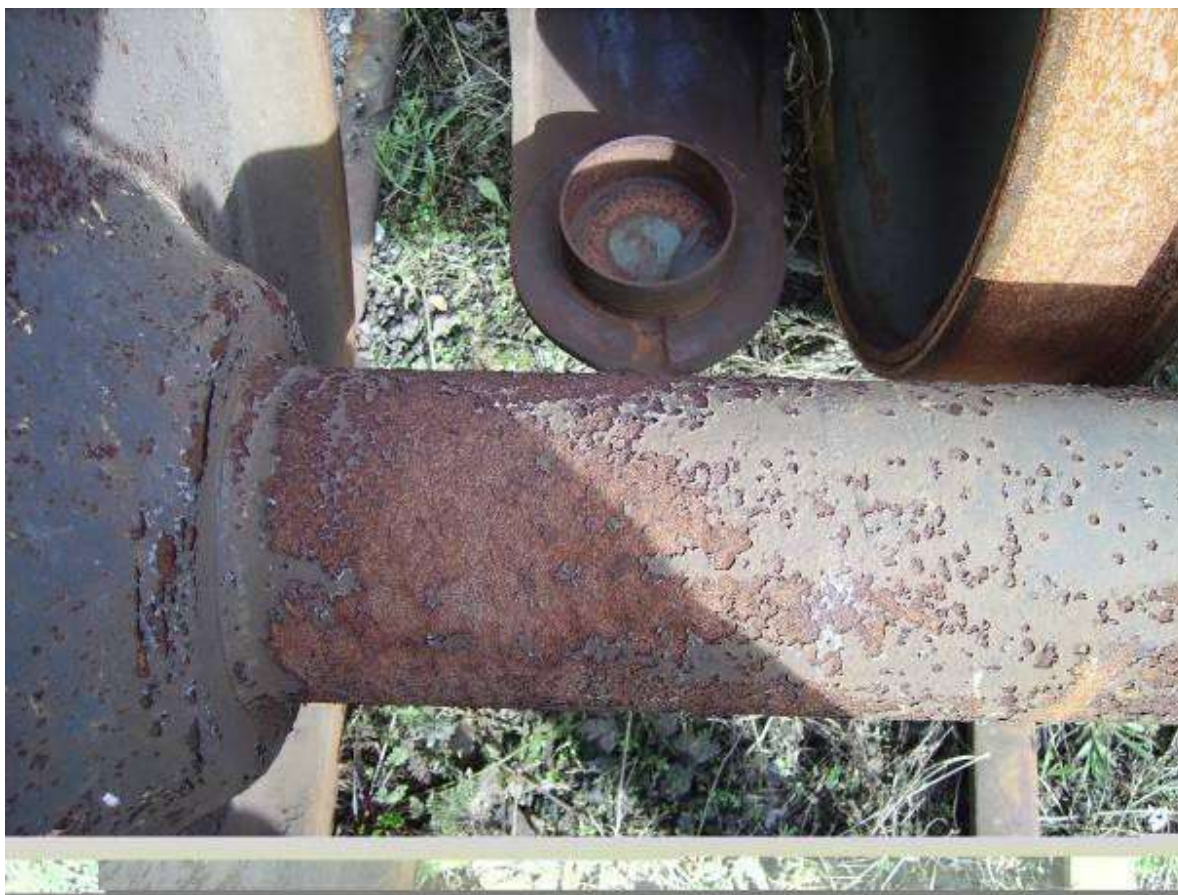
2) Large and heavily corroded areas, strongly and uniformly pitted surface

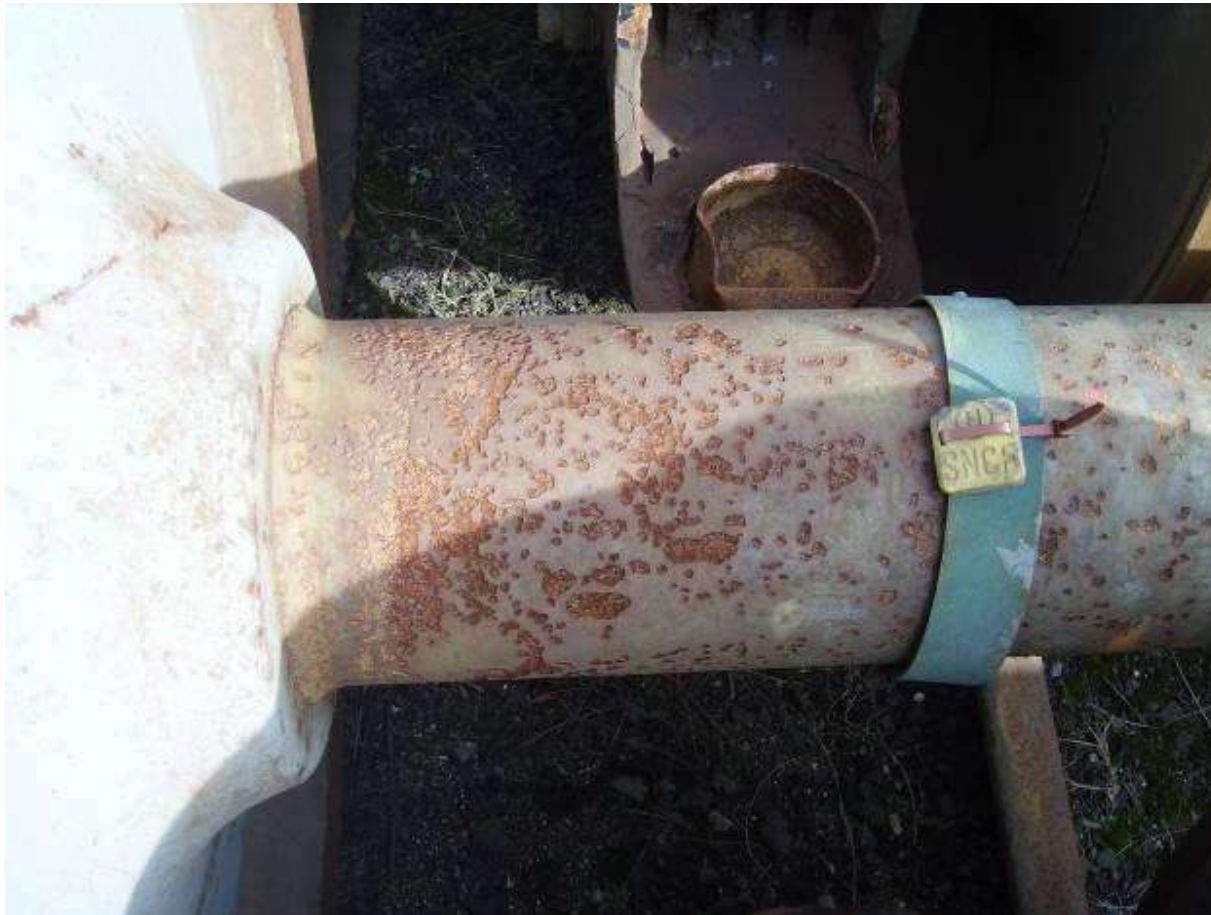
2) Large and heavily corroded areas, strongly and uniformly pitted surface

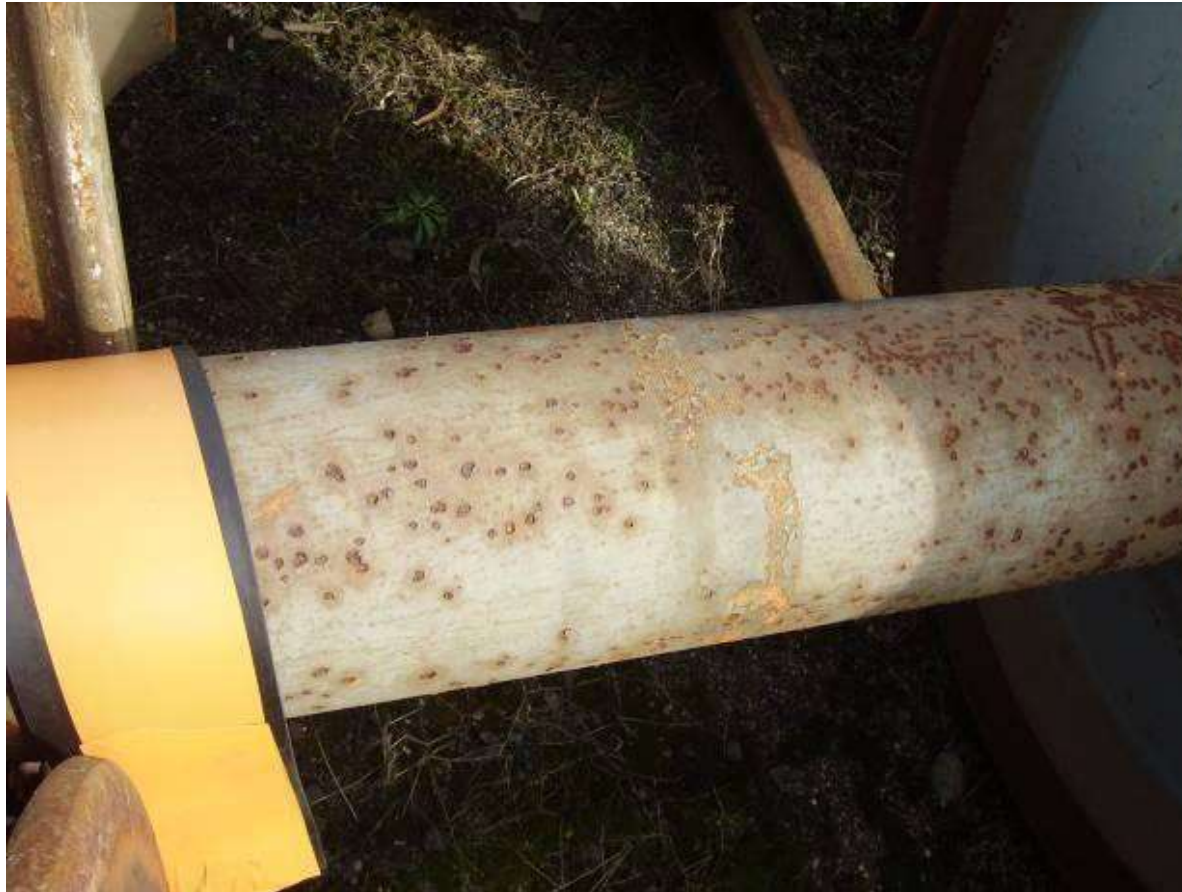
2) Large and heavily corroded areas, strongly and uniformly pitted surface

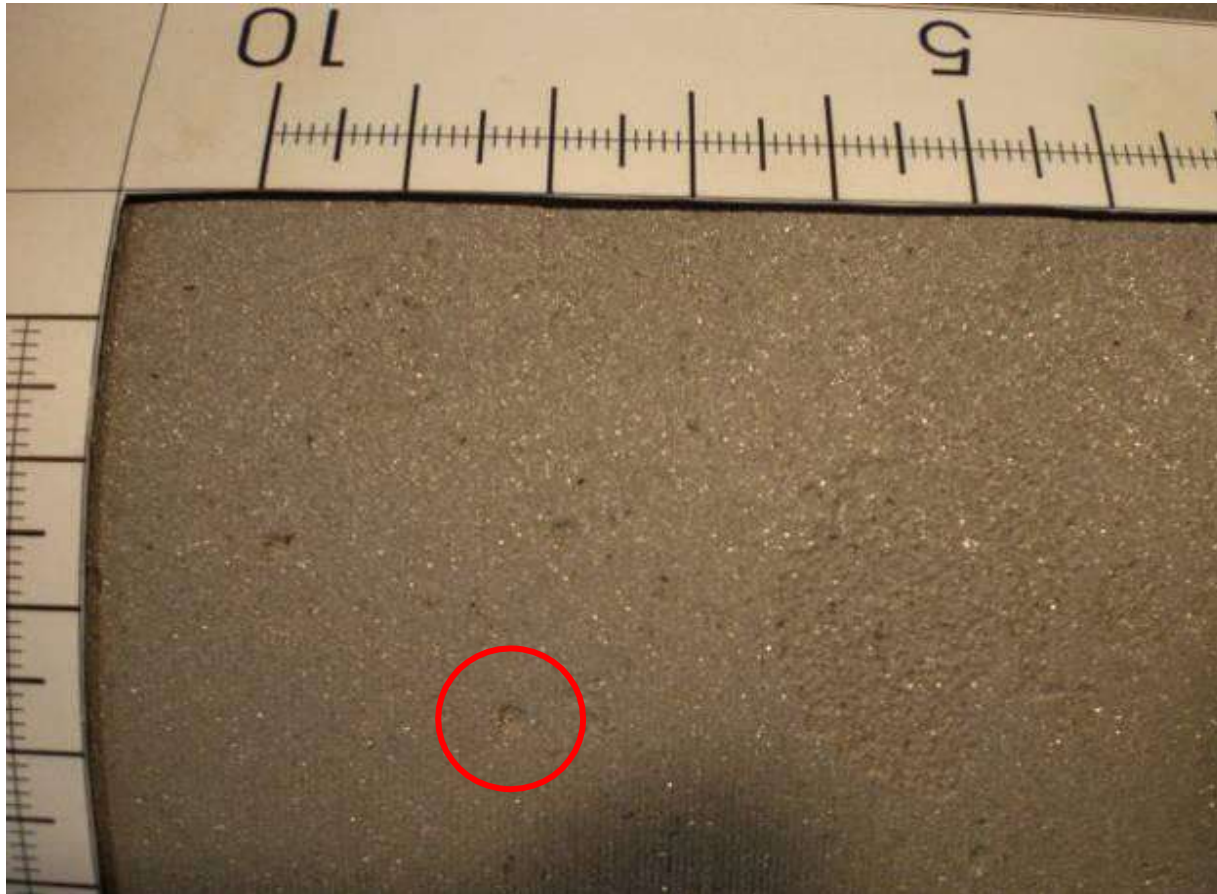
2) Large and heavily corroded areas, strongly and uniformly pitted surface

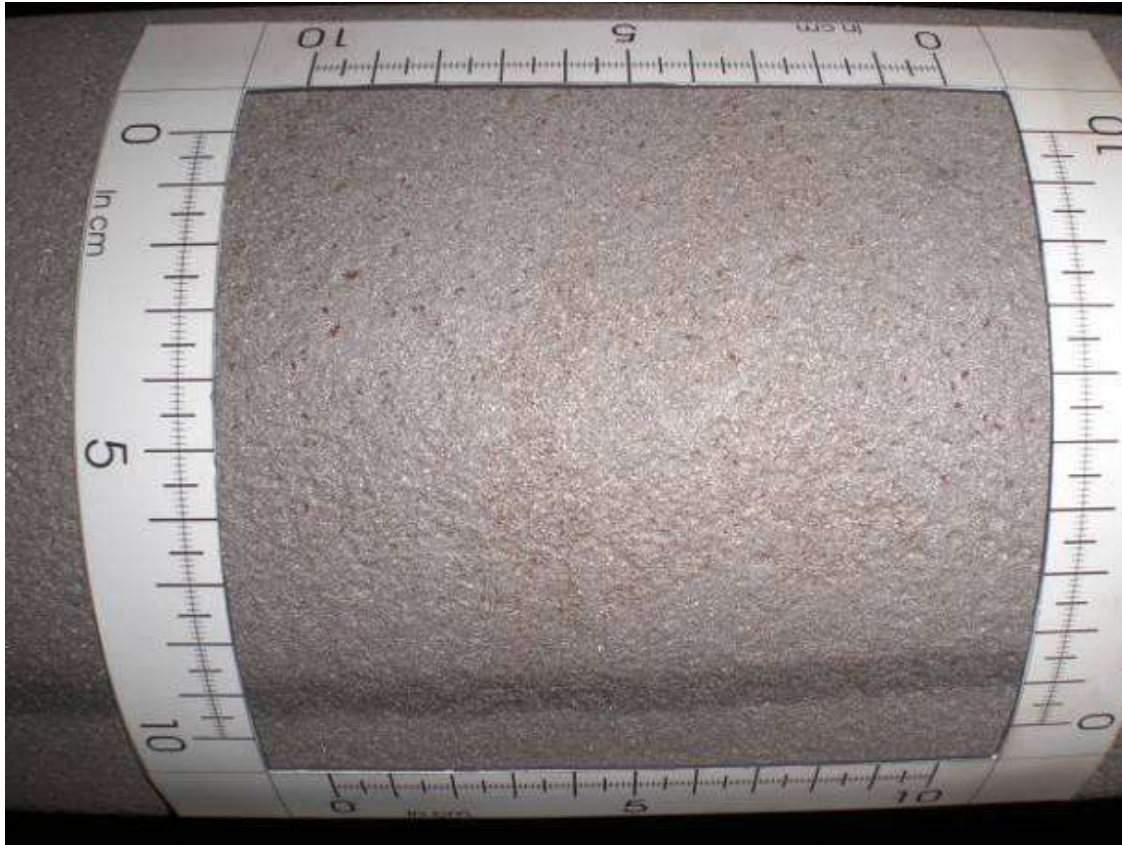
2) Large and heavily corroded areas, strongly and uniformly pitted surface

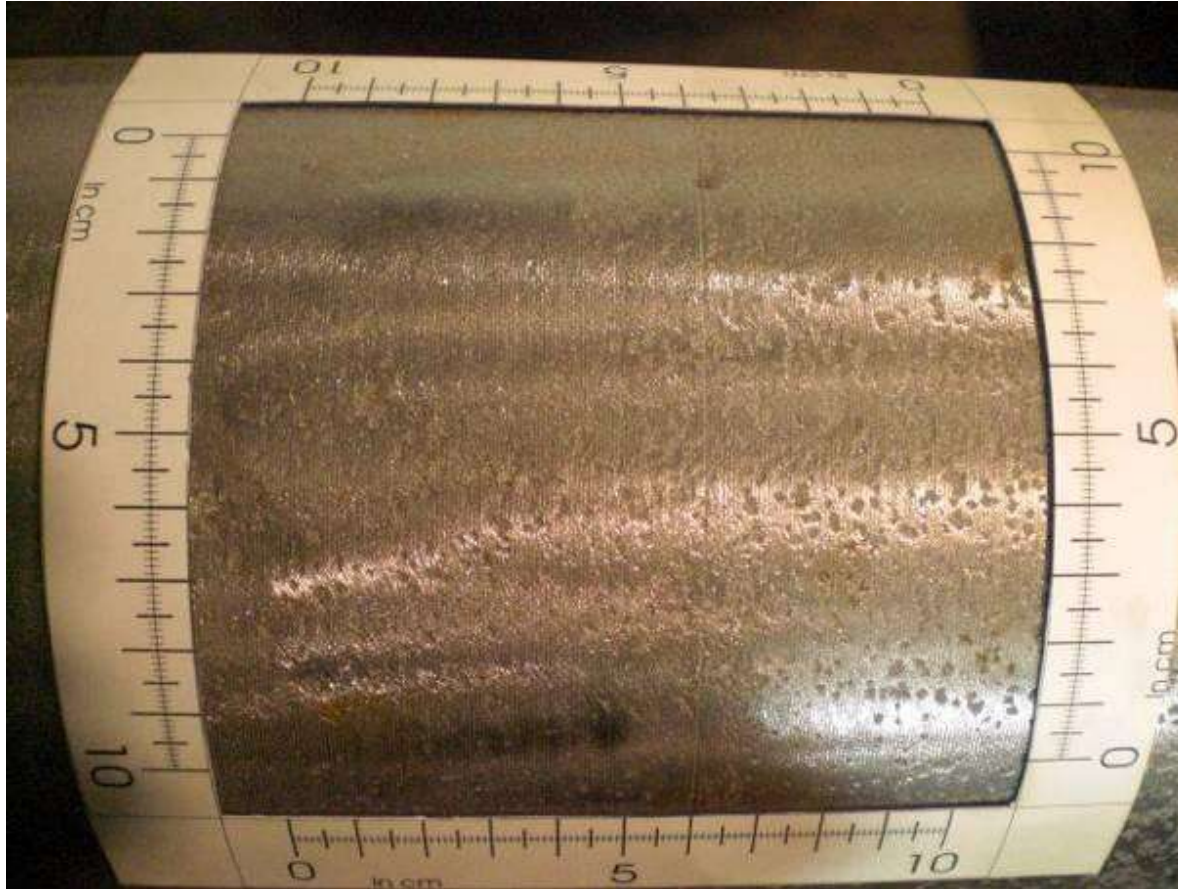
2) Large and heavily corroded areas, strongly and uniformly pitted surface

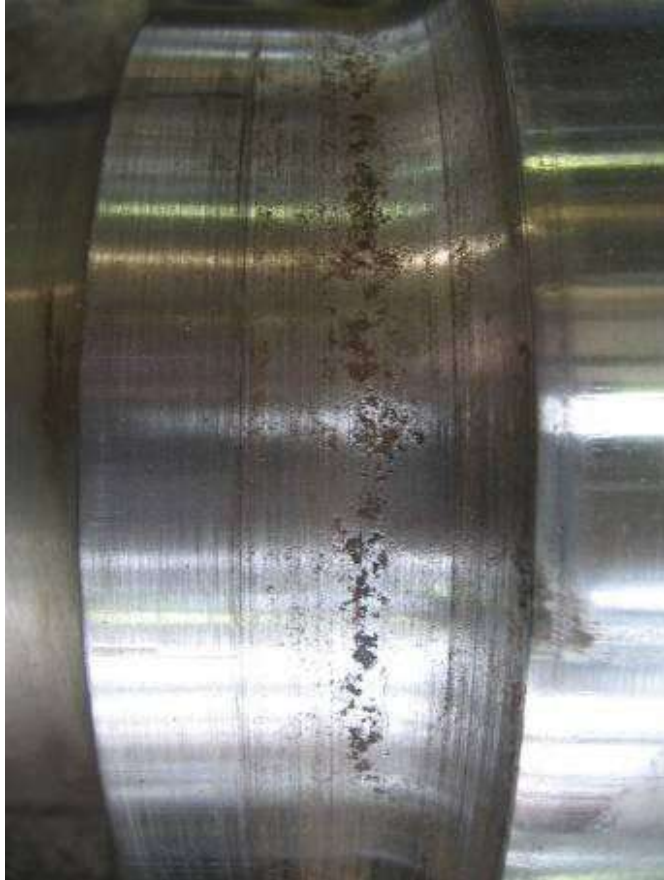
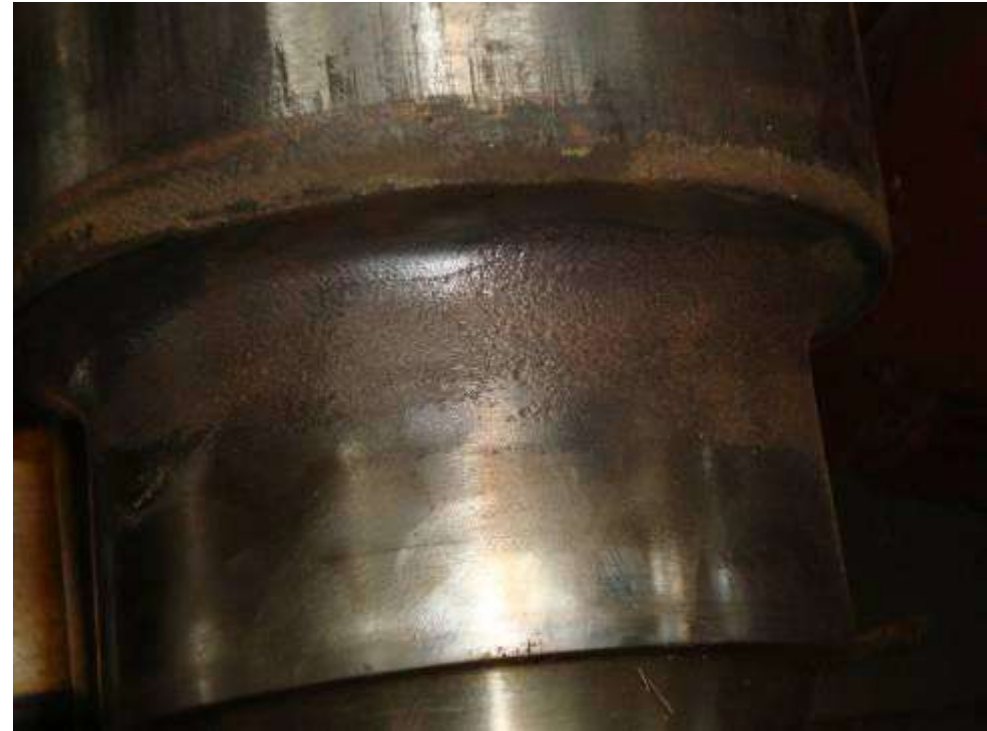
2) Status to be treated in transition radii and abutment area (examples)
