Final report on the results of the Joint Sector Group activities linked to the action plan defined under the Task Force Freight Wagon Maintenance

Joint Sector Group for ERA Task Force on wagon/axle maintenance

ANNEX 3.2.C: IMPLEMENTATION GUIDE FOR THE EUROPEAN VISUAL INSPECTION CATALOGUE (EVIC) FOR FREIGHT WAGON AXLES

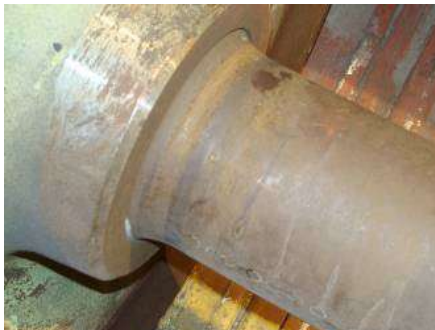
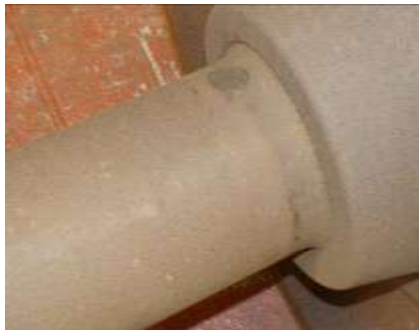
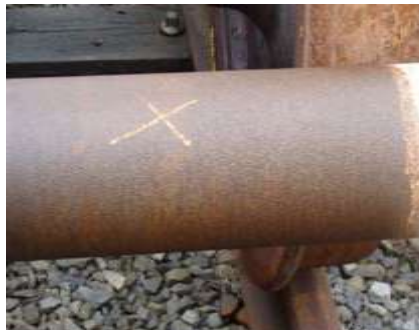
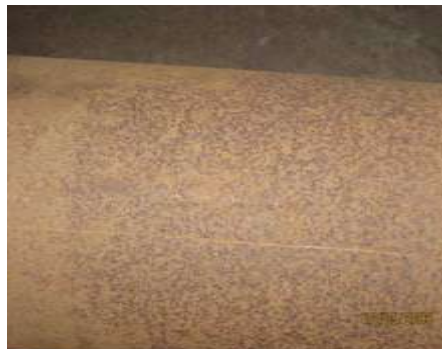
Pictorial representation:			
As new	Very good	Good	Acceptable

40 No defect - admissible surface appearance		Unpainted axles
Salient information:		
	There exist maintenance rules that do not require any anti-corrosion protection. Axles and wheels stay unpainted in such cases and show a thin and uniform layer of rust on their surfaces in service.	
	SNCB return on experience proves that application of such an axle maintenance system does not lead to any fatigue caused ruptures during service of an axle.	
Decision:		
	Deep corrosion is not accepted.	
	Leave in service wheelset “as new”, “very good”, “good” and “acceptable”	
	mark 1 at “ok” column in EVIC logging	O

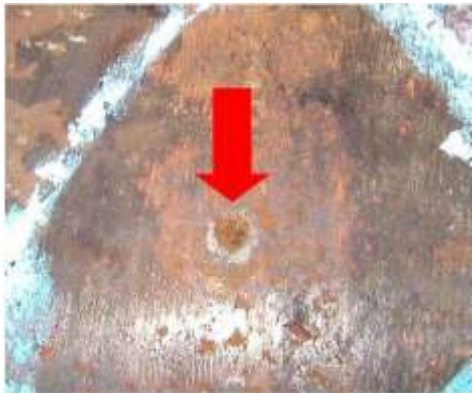
46 Surface damage – single, deeply pitted corrosion scars		Unpainted axles
Salient information:		
	Surface damage to the base material in the form of marked, local corrosion scars (resulting e.g. from chemical effects) is inadmissible.	
Decision:		
	Remove from service	Case B
	mark 1 at “X” column in EVIC logging	X

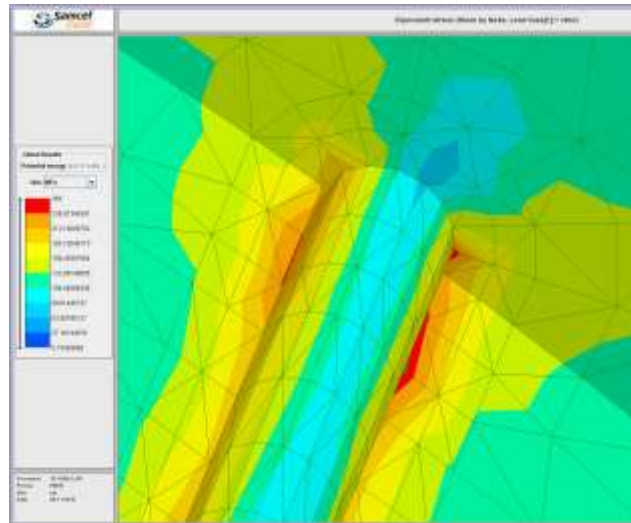
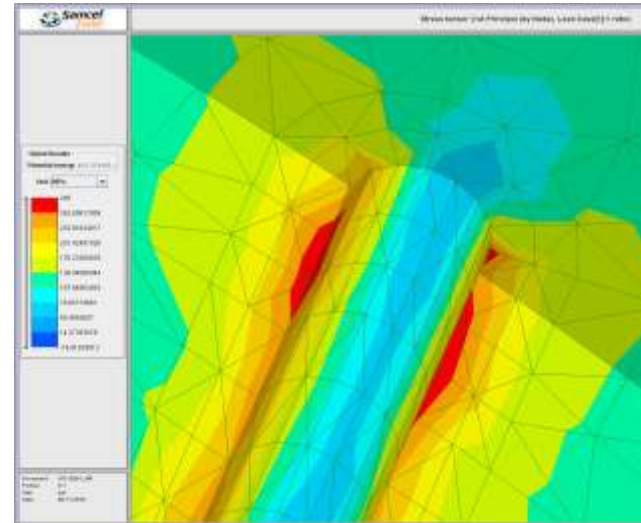
Maximum principle stress

$\sigma_{1max I} = 295 \text{ Mpa}$

In this case of the Notch I “cross-hole”, the associated
fatigue limit $\sigma_{col}^* = 99 \text{ MPa}$

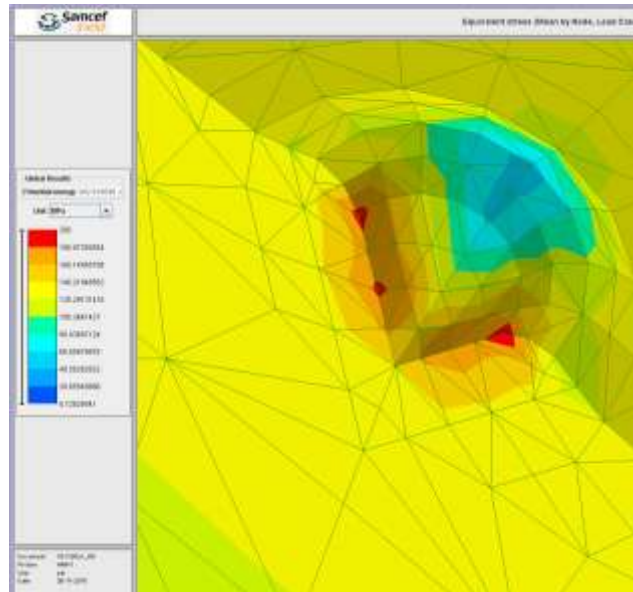
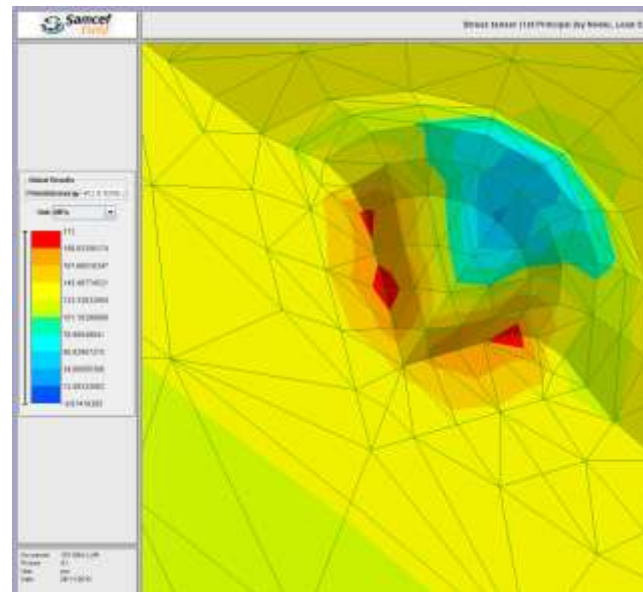
Maximum principal stress

$\sigma_{1max II} = 212 \text{ Mpa}$

By comparing the stresses of the standard notch cross-hole and the peak stresses of notch II (cone impression), the correction factor k_{kII} is determined for the fatigue limit of notch II (cone impression). The fatigue limit for the centre punch mark and/or notch II (cone impression) is derived from this with

$$k_{kII} = \sigma_{HMHmax I} / \sigma_{HMHmax II} = 265 / 200 = 1.32$$

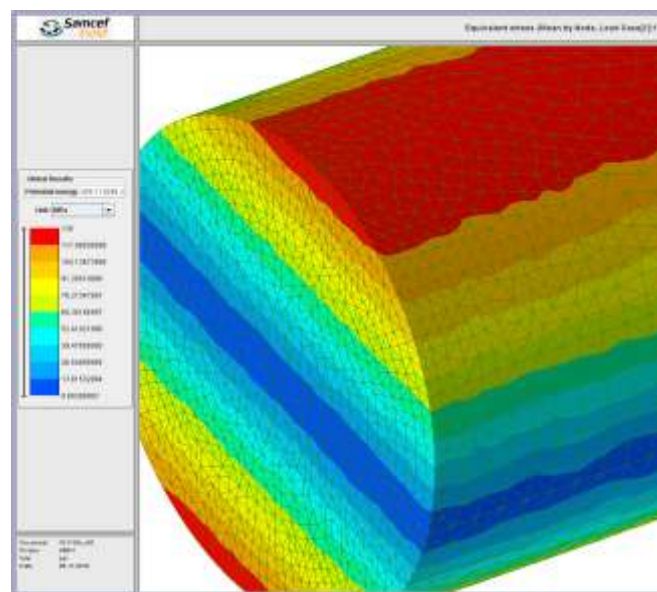
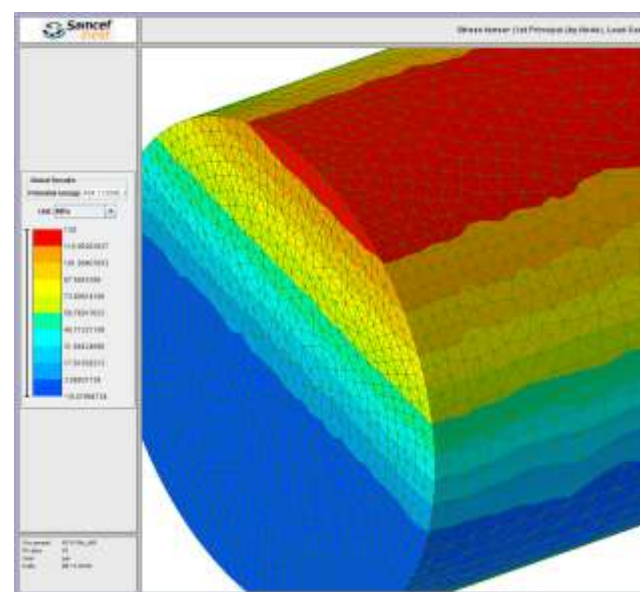
Maximum principal stress

$$\sigma_{1\text{max}}^{\text{“0”}} = 130 \text{ MPa}$$

The fatigue limit for the smooth shaft, the “zero-notch” thereby results

$$k_k^{\text{“0”}} = \sigma_{\text{HMHmax I}} / \sigma_{\text{HMHmax}}^{\text{“0”}} = 265 / 130 = 2.03$$

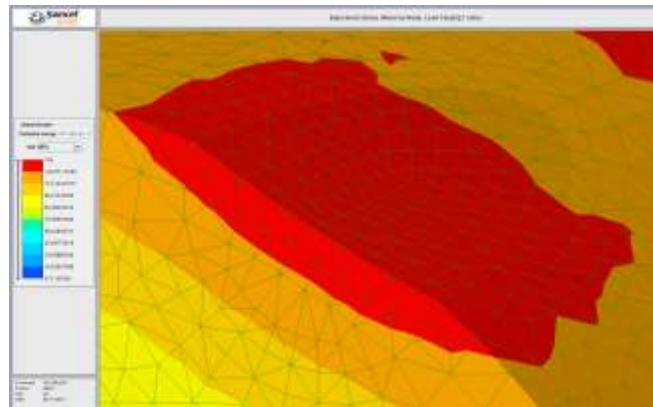
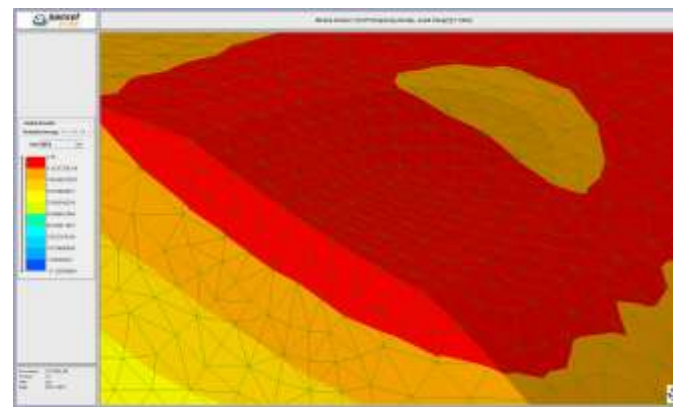
$$\sigma_{\text{HMHmax Mul}} = 140 \text{ Mpa}$$

$$\sigma_{1\text{max Mul}} = 139 \text{ MPa}$$

The fatigue limit for the oval, grinded out area (depth = approx 2 mm and diameter $d_x = 35 \text{ mm}$, $d_y = 70 \text{ mm}$) thereby results as

$$k_{k\text{Mul}} = \sigma_{\text{HMHmax I}} / \sigma_{\text{HMHmax Mul}} = 265 / 140 = 1.89$$
